# 2008 Diver Investigations of the Suspected *Serapis* Site Ambodifototra, Isle Ste Marie, Madagascar

**Authored by:**  
Michael C. Tuttle

**April 2010**

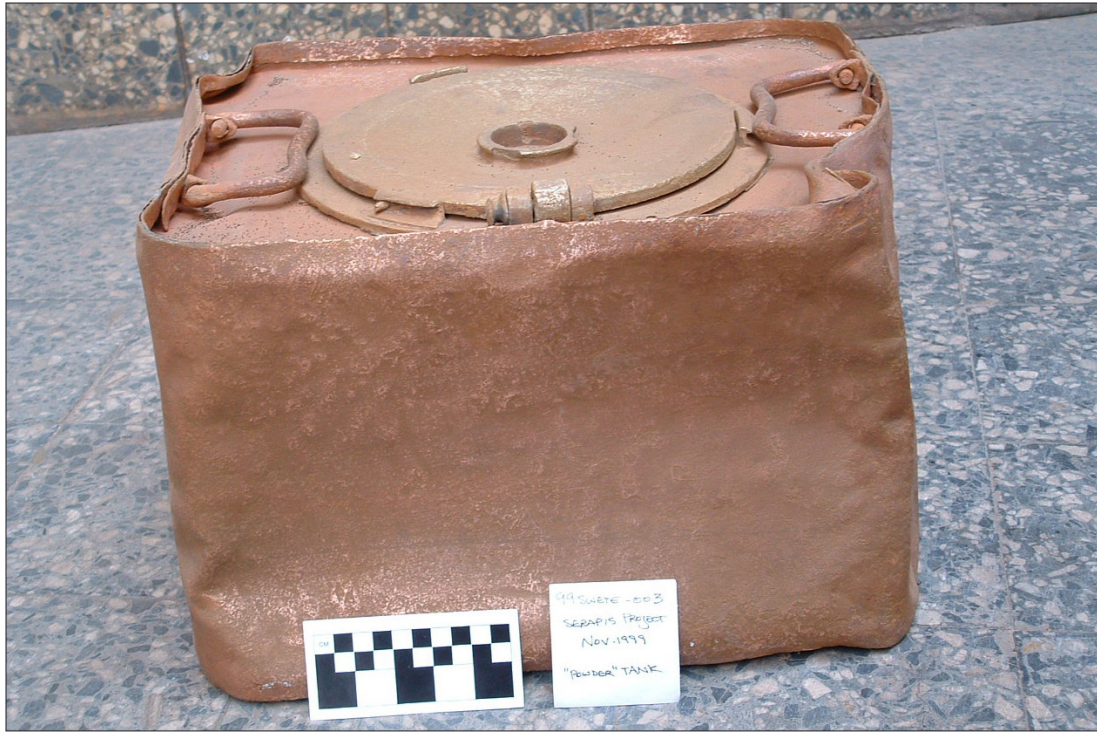
Figure 4. Copper container found in 1999 and conserved by Mr. Pierre van den Boogaerde.

A limited number of artifacts were recovered from the “Copper Site” in addition to the piece of copper bottom sheathing there was a copper container, a bullet, and an encrusted key. The items, including the copper sheathing and container, stayed in the possession of the University of Antananarivo and was cleaned and conserved by Mr. Pierre van den Boogaerde (Figures 4, 5). The copper sheathing was positively identified as sheathing used to protect a lower hull from bottom fouling and damage from ship worms (*Teredo navalis*). Ideas as to what was held in the copper container ranged from edible oils to gun powder. The other two items recovered including the bullet and the key were brought to the United States and sent to the conservation laboratory at Ships of Discovery in Corpus Christi, Texas for treatment. The objects have since been returned to the University of Antananarivo (Appendix A). The key and bullet appear to post date the sinking of *Serapis* and are considered to be intrusive material, not uncommon in an active harbor environment.

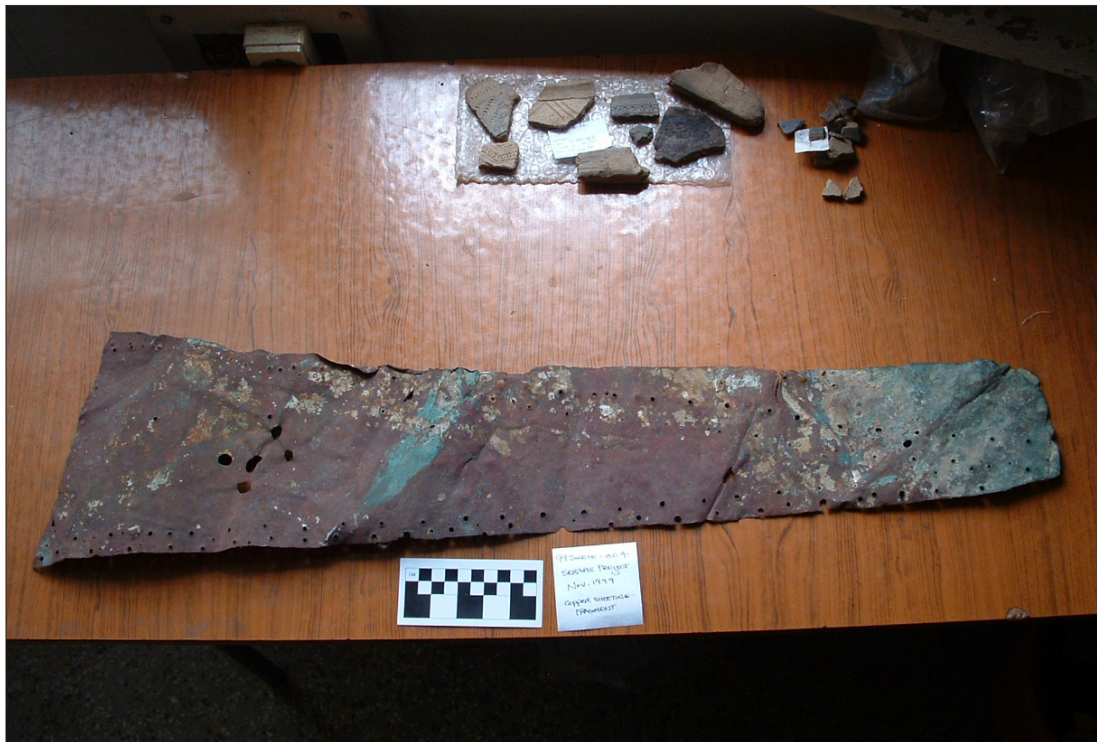
Figure 5. Copper bottom sheathing conserved by the Institute of Civilizations/Museum of Art and Archaeology at the University of Antananarivo.

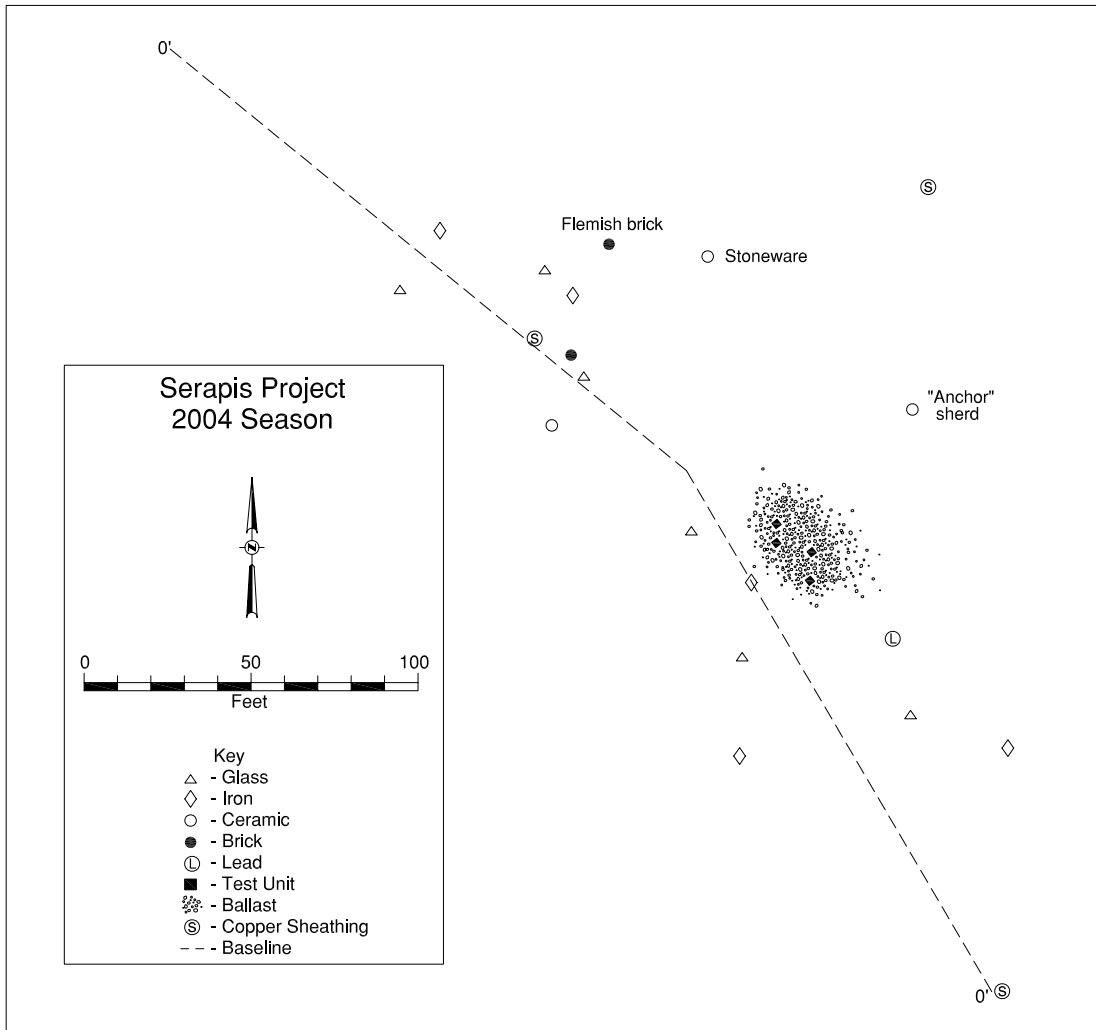
Figure 6. 2004 site plan of the “Copper Site” (Illustrated by Mr. Greg Cook, University of West Florida, digital image by Lee McKenzie).

Diver investigations were conducted for seven days. The team recorded all bottom features, including a sizeable scatter of isolated artifacts, ballast stones, and copper sheathing (Figure 6). No excavation of the site was undertaken during the 2004 field season. Although ballast stones and copper sheathing were recorded across the harbor floor, no ship timbers or hull structure were located (Figures 7, 8). Additional artifacts in the area included ceramics,

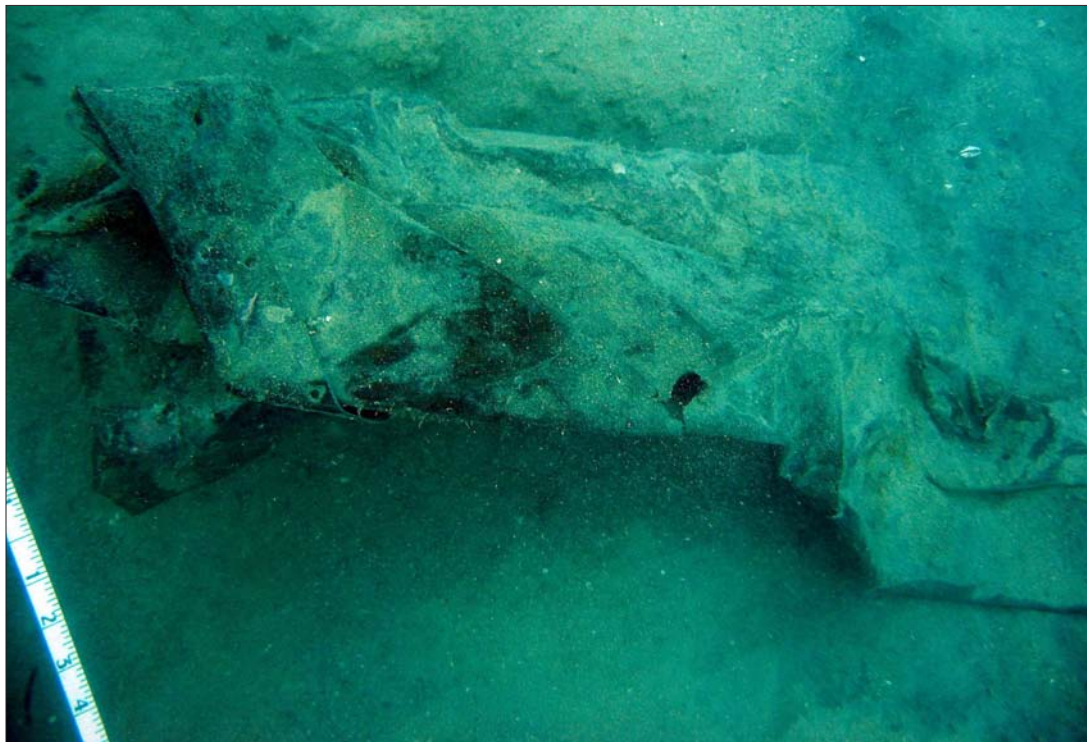
Figure 8. Copper hull sheathing protruding from the seabed.

The presence of copper sheathing was also a very good indicator that the *Serapis* might be located near the area under investigation. However, it should be noted that Isle Ste Marie was a French East India Company station and French naval vessels would not have been a rare site in the harbor (evidenced by *Serapis* stopping on the island before transiting to another destination). While it is plausible that one of these vessels may have lost bottom sheathing for any number of reasons the coincidence of both the ballast and sheathing located in proximity to one another begged further investigation.

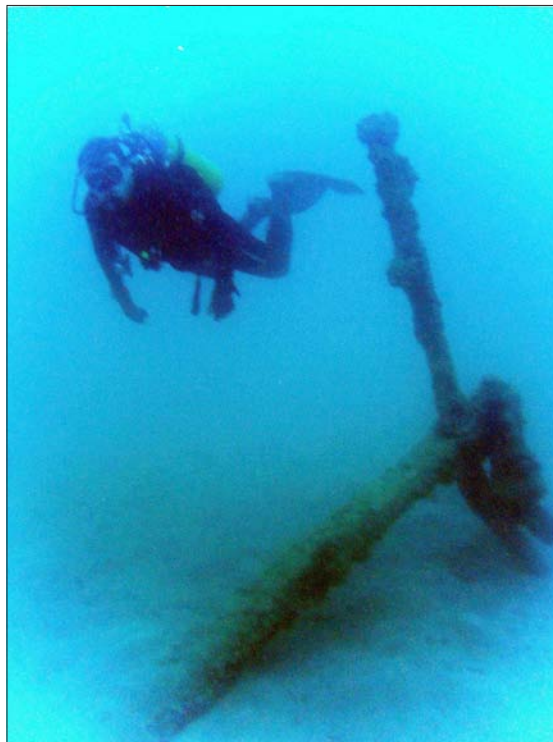
Figure 17. Diver swimming past a nineteenth century anchor north of the suspected *Serapis* site.

On November 20, 2008 archaeologists with the Serapis Project (with the guidance of local dive shop owner Mr. Max Felici) made an initial inspection of the unidentified shipwreck located in the harbor of Ambodifototra. Descending to the wreck site divers quickly noted the presence of a large, nineteenth century folding stock anchor sitting upright on the harbor floor, approximately 50 feet north of the unidentified wreck (Figure 17). Although the anchor (which post dates *Serapis*) is not associated with the investigated wreckage, it does represent evidence of continual harbor use.

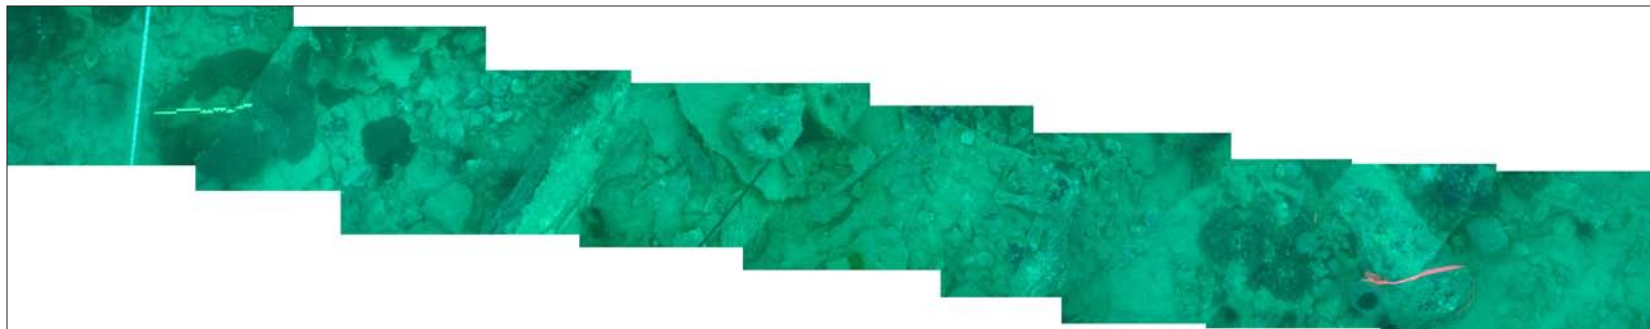
Figure 19. One transect of photographs stitched together will help produce a complete photo mosaic of the wreck site.

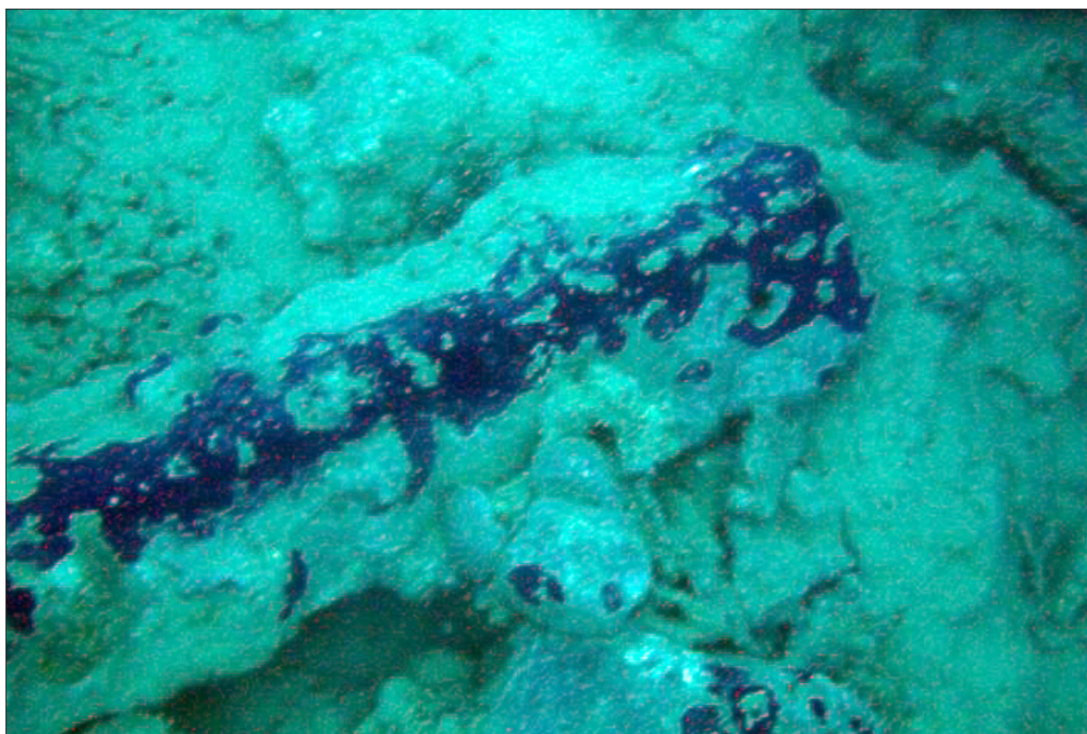
Figure 23. Possible lead ballast bar identified onsite.

It is interesting to note that the ballast bars found on the suspected *Serapis* site represent a unique find compared to the other vessels mentioned above. A magnet taken to the wreck site was placed on the ballast bars to determine whether they were made of iron or another metal. The magnet did not stick to any of the bars suggesting the bars are not made of iron but likely lead. The concretion on the ballast bars was a noticeably different color than the

The ballast from the *Adelaar* did not exhibit much growth in the form of concretion; in fact the ballast bars were essentially clean. In comparison the surface of the ballast bars from the *Serapis* were somewhat rough and bubbly in texture. It is plausible the difference in corrosion may be caused by a difference in ambient conditions between these two wreck sites. The *Adelaar* wrecked off the east coast of Scotland in a dynamic surge environment whereas the vessel in Madagascar is located in the relatively calm harbor at Ambodifotra. The warmer water temperatures in Madagascar may also help explain the concretion on the ballast bars versus the lack of concretion found on the ballast bars off Scotland.

Future analysis of these ballast bars is recommended. This may include weighing individual bars and conducting a compositional analysis to determine the elemental constituents of these bars. Additionally, maker's marks and weight stamps may become visible after the cleaning and conservation of some of the ballast bars.

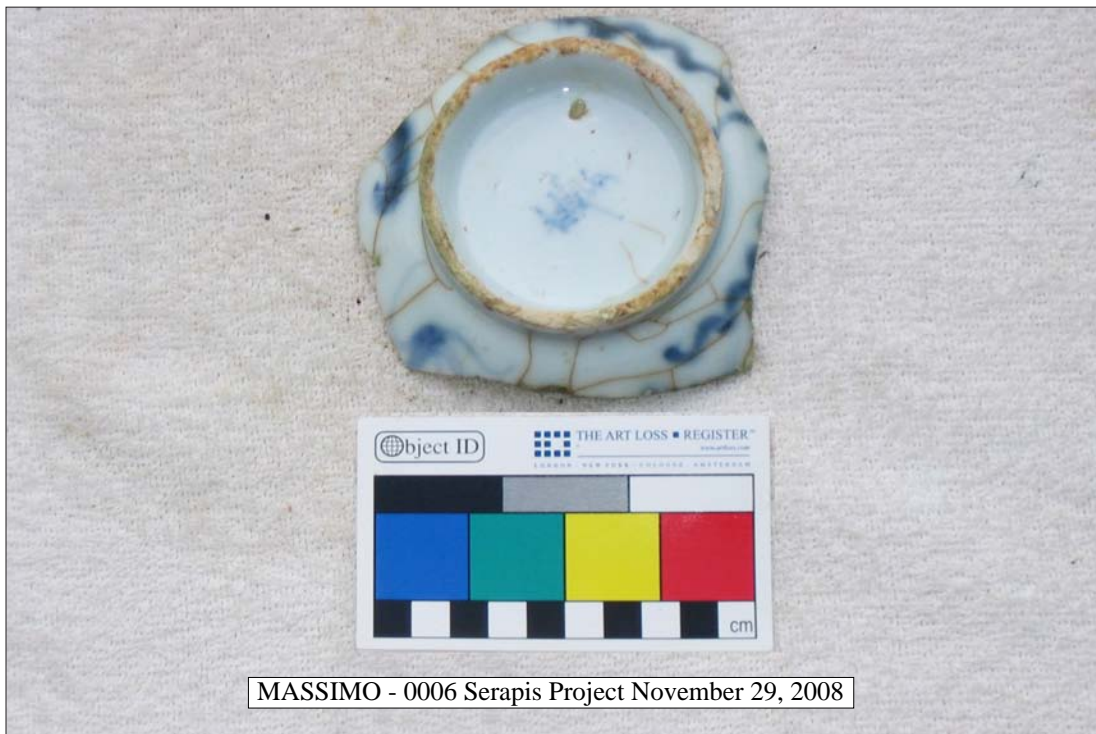
Figure 25. Porcelain bowl with opaque glaze and hand painted blue motifs.

This bowl was also identified as possibly Canton Ware, which usually consists of a white, or greyish white, glass-like vitreous paste (Debra Wells, personal communication, February 25, 2009). Glaze on Canton ware is generally of a poorer quality than on other porcelain types, and tends to have occasional pinholes and an imperfect texture. The background color is typically grayish white. Design execution is usually simple, using bold brush strokes and various shades of blue ranging from watery grayish-blue to cobalt. It was often referred to as "Ballast ware" due to the high number of wares often shipped and sometimes used as actual ships ballast (Deegan 2009). Mean dates for Canton Ware are typically 1790-1835.

Both suggested dates for the blue and white bowl base are late or post-date the suspected *Serapis* shipwreck. As stated earlier, due to the location of the wreck site and the dynamics of the harbor it is quite possible that the ceramic piece is intrusive. However, blue and white export ceramics have been located on the 1760 *Machault* shipwreck in Chaleur Bay (Sullivan 1986:66, 68-73). The widespread distribution of these ceramic types at French-colonial sites suggests it is not unlikely that blue and white wares would be found aboard *Serapis*. "Oriental-style ceramics" have also been found on the HMS *Swift*, lost 1770. The collection from the *Swift* include porcelains, red stoneware, fine earthenware and coarse earthenware, some with apparent makers marks (Elkin 2006), marking a further indication that these types of finds are not uncommon on wreck sites of the era.

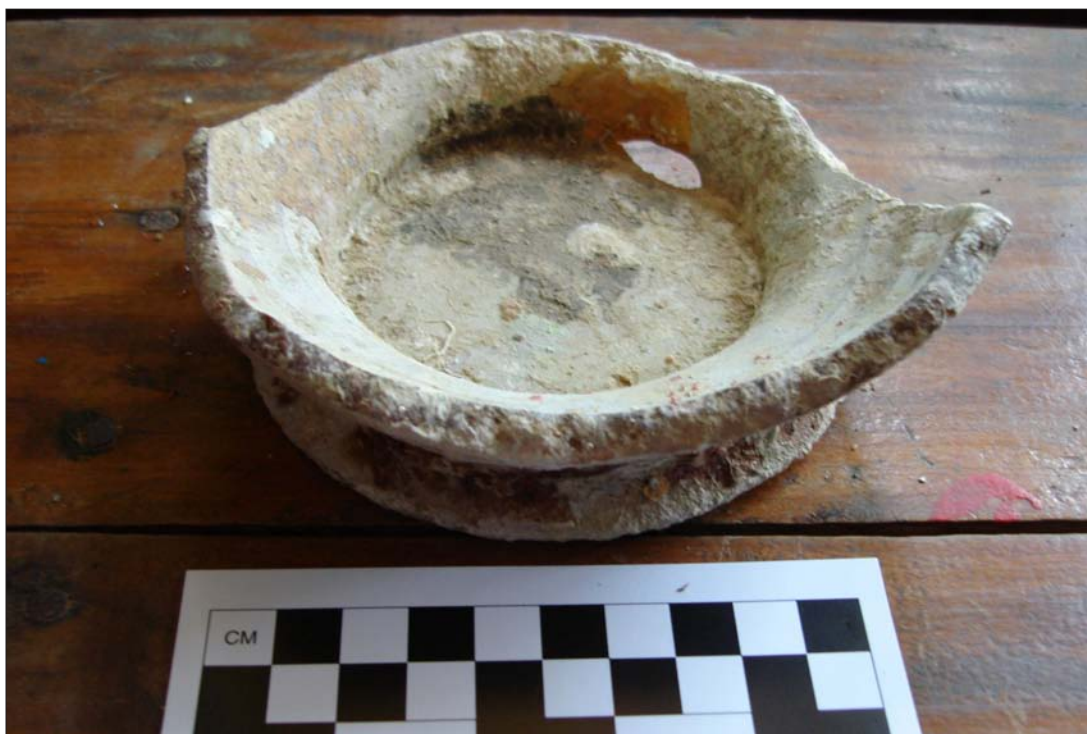
Figure 27. Image of tin glazed bowl base.

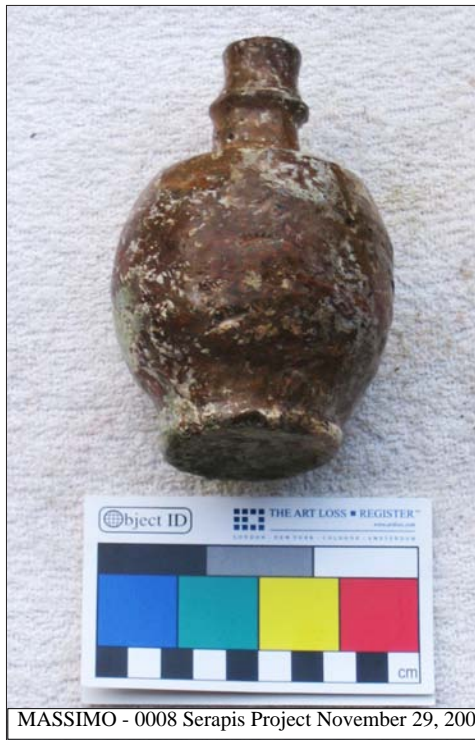
MASSIMO - 0008 Serapis Project November 29, 2008

Figure 28. Unglazed earthenware jar/decanter.

One unglazed roughly-made grit tempered earthenware jar/decanter (Massimo-0008) was reportedly recovered from the site (Figure 28). The vessel was obviously hand formed, with one side slightly flattened. This was likely due to the maker holding that area as he/she formed the vessel or the vessel was lying on that side in the kiln. There are visible tool markings on the exterior. The paste is a brownish/red color, with small amounts of visible stones in the paste. No exact match for this form has been located as of yet; however, Waselkov noted that he has seen this form before in a French context, but could not recall within which context (Greg Waselkov, personal communication, 2009). Other vessels resembling this object can be seen within North American French colonial collections from

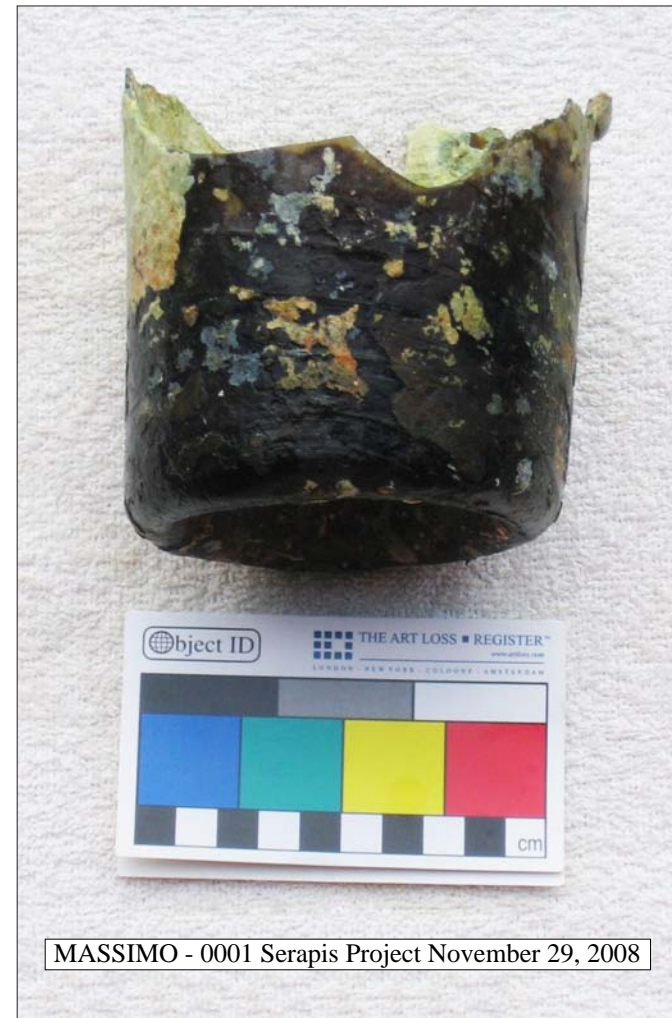
Figure 30. Image of olive green glass bottle base.

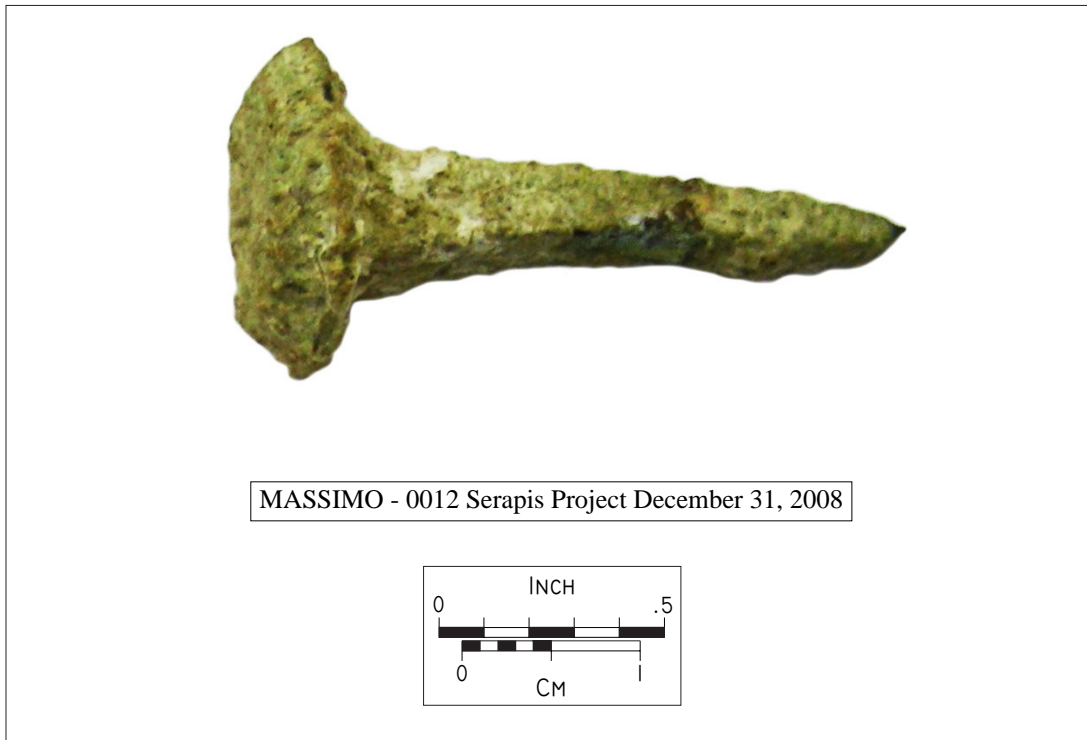
Figure 32. Copper fastener.

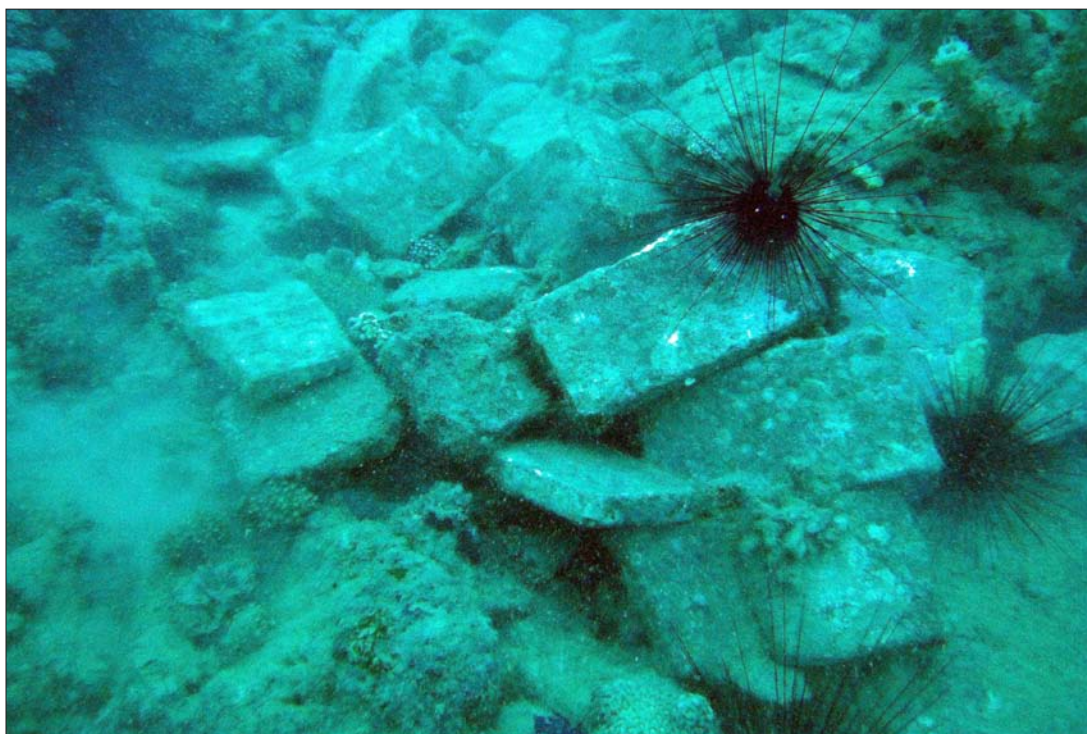
Figure 34. Brick assemblage located on the suspected *Serapis* site.

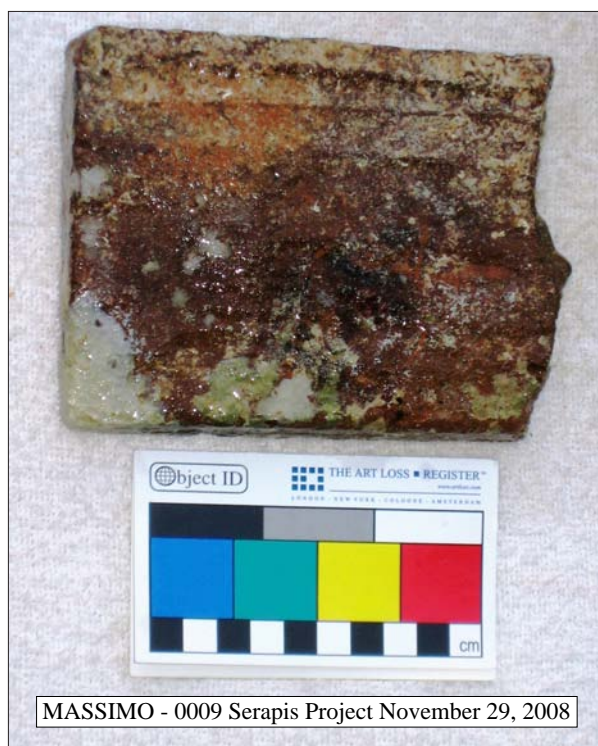
Figure 35. Image of recovered brick.

Two brick/tile fragments (Massimo-0009, Massimo-0010) were recovered from the wreck site by sport divers and were documented by members of the *Serapis* Project (Figure 34, Figure 35). Both bricks have a reddish yellow body (Munsell 7.5yr 6/6: reddish yellow) with a fairly smooth paste. These bricks were probably formed by hand in a wooden or iron-clad mold, a common practice used until the 19<sup>th</sup> century.

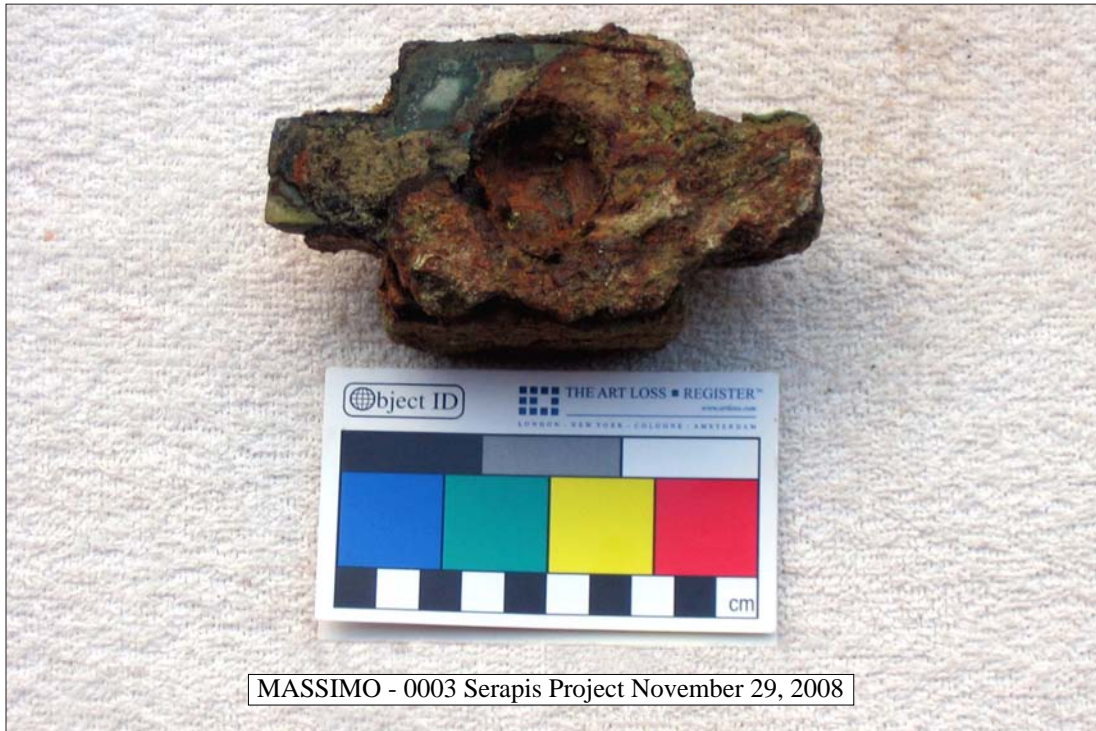
MASSIMO - 0003 Serapis Project November 29, 2008

Figure 36. Copper alloy coak from the suspected *Serapis* site.
